APPLICATION : Cement industry
LOCATION : Ireland
DIFFICULTY : Dust & elongation
TYPE OF CHAIN : Transmission

CUSTOMER SUCCESS

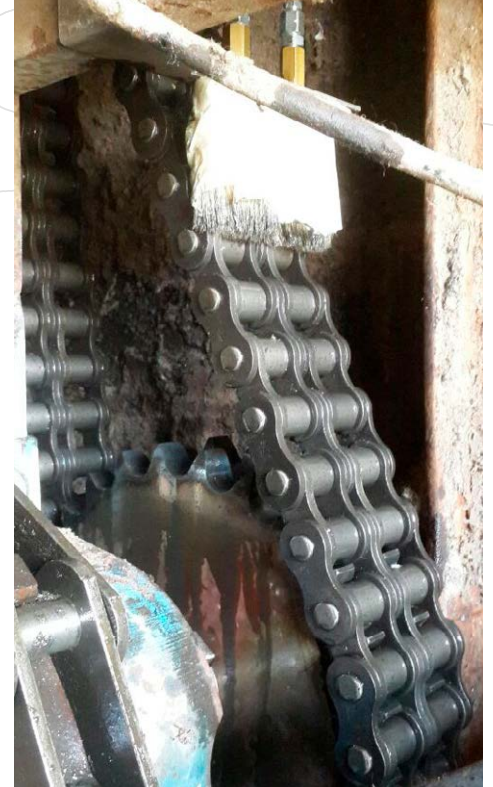
In a cement factory, the customer used on their application a **competitor's solution range 24B-2** transmission chain. But the **dusty and abrasive environment** as well as a **frequent lack of lubrication** generated such an elongation that the chain had to be changed after **6 to 8 weeks maximum**.

Sedis engineer with the support of the technical department proposed them to use the **anti-wear DELTA® HR chain**, coupled with an **automatic lubrication system with brush**. The results were beyond expectations : the chain was replaced **after 1 year of operation** ; which is a service life **multiplied by 6** !
